Buckner Model VBDW Disassembly Instructions and Troubleshooting

SUPERIOR

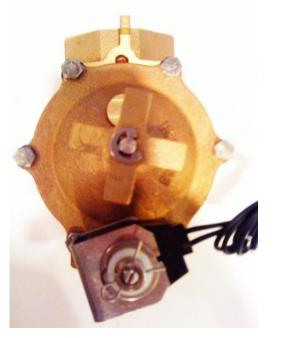
1. Remove the metal clip at the top, then remove the plastic spacer and metal washer that sits on top of the metal U-frame.

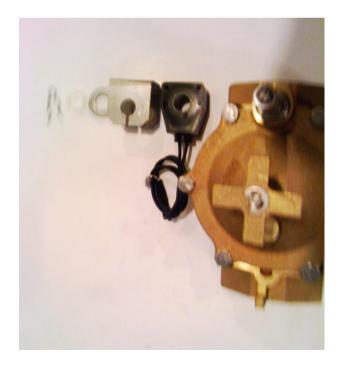
2. Lift coil and U-frame off of the solenoid post.

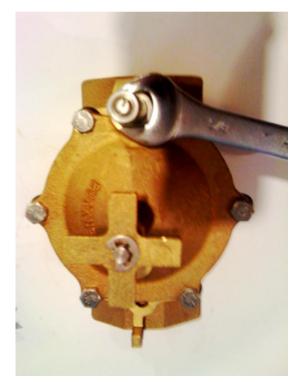
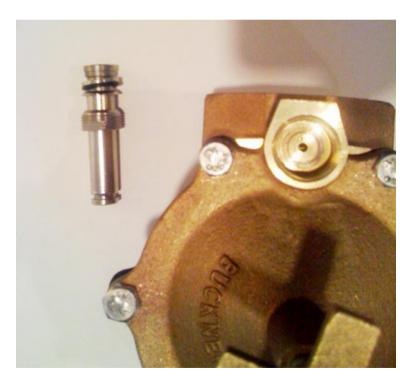
3. Using a 5/8" wrench, unscrew solenoid post from valve bonnet. The wrench can be applied to the flats in the threaded base.

Photo below shows solenoid cavity and solenoid post assembly.

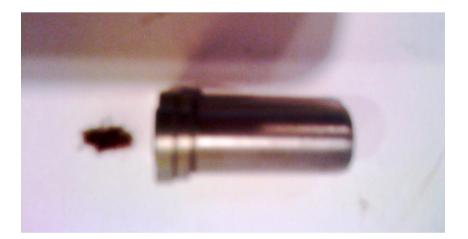
Photo below shows filter material from interior of lower section of post assembly. The filter prevents particulates from entering upper diaphragm chamber.

Disassemble solenoid and remove filter from lower section of solenoid post assembly using a paper clip or something similar. Clean filter with water or replace. The filter is made of Scotch Bright (very fine type A) which can be purchased at most super markets.

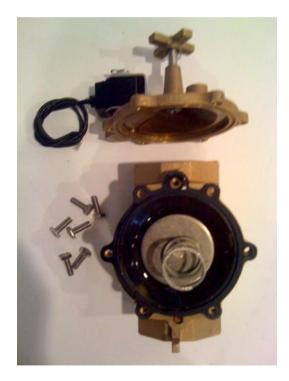
1. Remove top bolts, then lift bonnet assembly off of valve body.

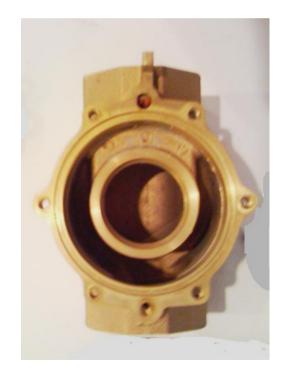
2. Remove spring and diaphragm assembly from valve body

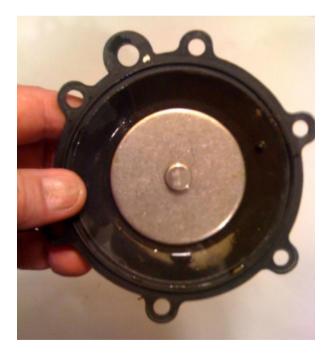
Photo below shows top side of diaphragm assembly.

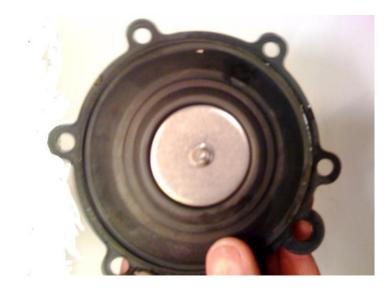
Valve will not close, or closes but weeps. CAUSE #1:

Debris in valve body or embedded in rubber seat.

Disassemble valve and check for debris and clean as necessary. If rubber seat is damaged, replace diaphragm/seat assembly.

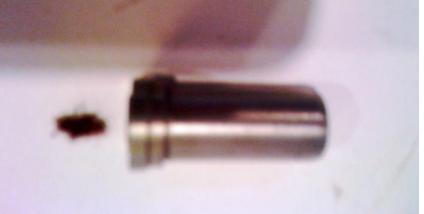
Valve will not close.

Clogged filter in solenoid is not allowing water to pass into diaphragm chamber.

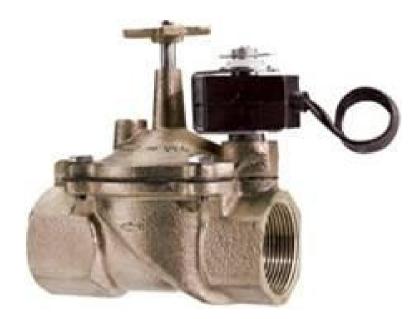
Water weeps past valve and out of top of solenoid post.

Malfunctioning solenoid. The solenoid plunger is not completely sealing exhaust port located at top of post.

Disassemble solenoid post and plunger assembly and look for debris that could prevent plunger from sealing exhaust port. Remove debris. If no debris is found, replace post and plunger assembly.

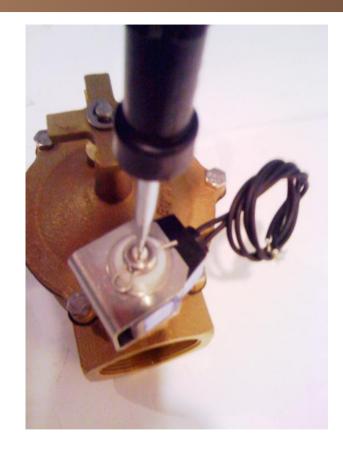
Valve will not open electrically or manually.

Torn diaphragm. This can be confirmed by attempting to open the valve electrically or manually (by turning screw at top of solenoid post clockwise as many turns as possible). If water exhausts continuously out of solenoid exhaust port located at top of solenoid post but valve does not open, or opens only part way, torn diaphragm is confirmed.

Replace diaphragm/seat assembly.

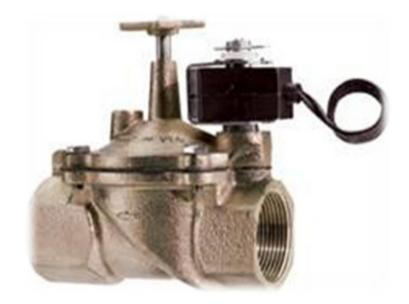
Valve will not open electrically.

Solenoid is not energizing. This could be due to: 1) no station output from the controller

- 2) broken or disconnected wire
- 3) bad solenoid coil.

Using a volt meter, check the station power output from the controller. If 24 VAC output is confirmed, disconnect solenoid leads from valve wires and, using a volt meter, measure power at the valve. If there is a reading of 18 VAC (minimum voltage needed to open valve) or more, then replace solenoid coil. If there is no voltage reading, then the problem is due to a damaged wire between the controller and valve.
